# Feasibility Study (Revision 1)

## Organizational Maintenance Shop #28

**1622 South Broad Street, Mobile, Alabama 36605**

Prepared by:  
AECOM Technical Services, Inc.  
Greenville, SC

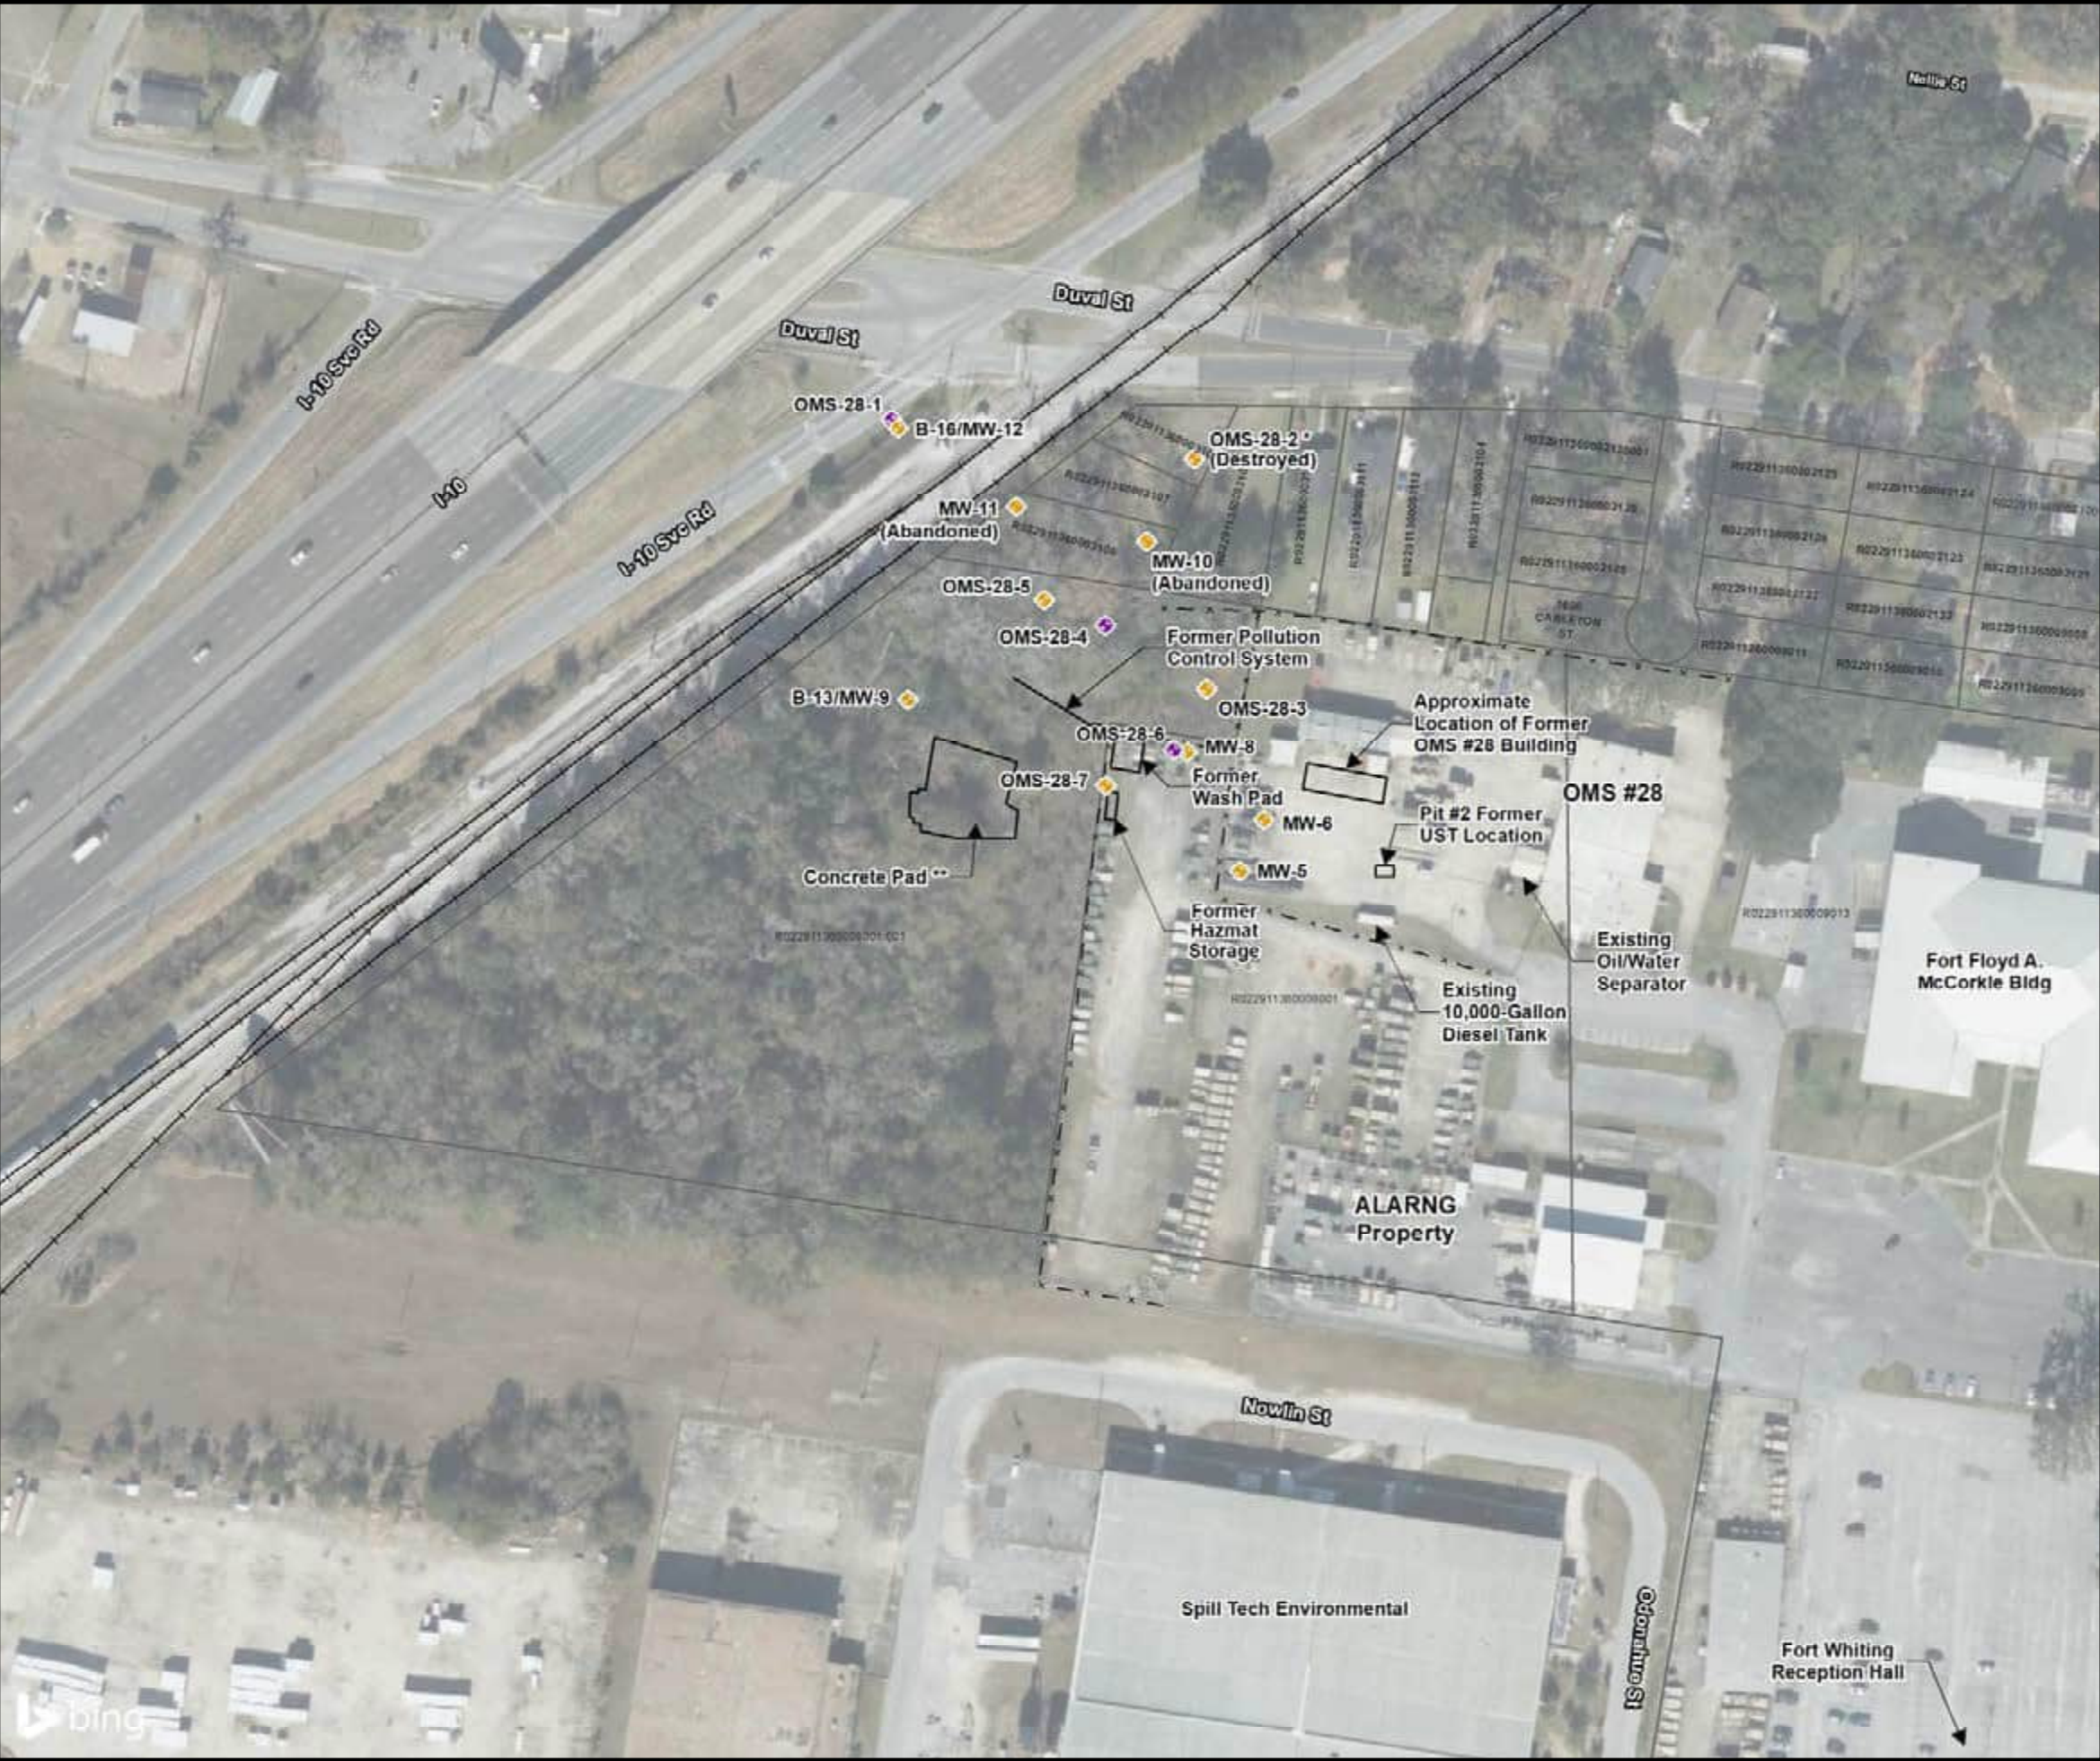
| PROJECT NO.<br>60666895 | DRAWN BY:<br>RJS | DATE:<br>10/12/2023 | Figure 1-2 |

A concrete pad measuring approximately 50 feet wide by 50 feet long was observed in the wooded area approximately 50 feet west of the fenced ALARNG property (**Figure 1-2**). The concrete pad was noted to correspond with the approximate former location of “Mollison Hall” as depicted on historical Sanborn Maps and is possibly a building foundation remnant. Online research by Louis Berger suggested that Mollison Hall was used as a recreational building for soldiers before and after World War II and is therefore, not suspected to be associated with the TCE and PCE soil and groundwater contamination observed. A historical aerial photograph review indicated that Mollison Hall had been demolished between 1972 and 1974, and only a concrete foundation remained (Louis Berger, 2015).

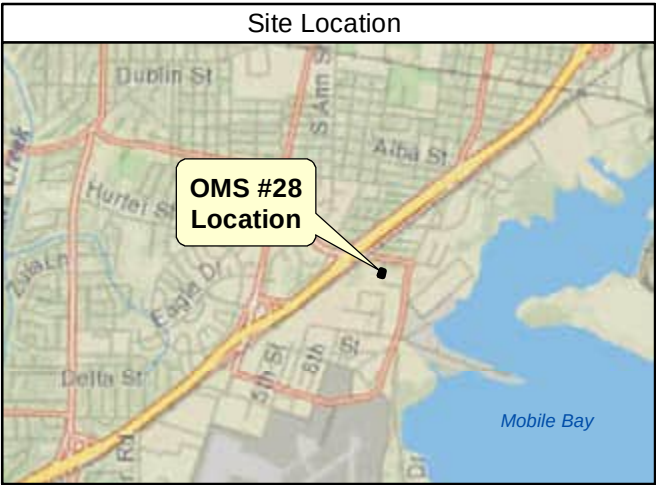
- Upper/Middle Surficial Monitoring Well Location
- Lower Surficial Monitoring Well Location
- Railroad
- Fenceline
- Parcel Boundary

**Notes:**  
Wells MW-10 and MW-11 were abandoned in 2008 at the property owner's request and have not been replaced.

\* Wells OMS-28-2 was found destroyed during a site visit in December 2021.

\*\* Concrete pad is the likely remnant foundation of Mollison Hall (recreational hall for soldiers before and after World War II) that was demolished between 1972 and 1974.

A vehicle wash pad was formerly located in the far northwestern corner of the parking lot until 1978 (**Figure 1-2**). The wash pad was constructed as a concrete slab with no drainage system in place. Military vehicles were routinely washed in this area, and the wash water that was generated flowed freely onto the ground.

Quarterly groundwater monitoring for petroleum-related contaminants subsequently began in 1995 and continued through 2004. When analysis of quarterly groundwater sampling results indicated that petroleum contamination had migrated beyond the original site monitoring well network installed during the December 1994 groundwater investigation, further site characterization was determined to be necessary. This additional site characterization work was conducted in 2004 and 2005 by Bechtel-S and consisted of the installation of additional monitoring wells at the site in another attempt to delineate petroleum contamination associated with Pit 2 (Louis Berger, 2015). **Figure 1-2** shows the investigation area and relevant historical features.

Based on the investigative work completed prior to 2015, the potential source area for the TCE plume appeared to be within the vicinity of MW-8, which also corresponded with the largest suspected area of residual soil contamination. MW-8 is located approximately 40 feet to the east of the former wash pad along the westernmost boundary of OMS #28 in an area where military vehicles and equipment are currently stored. PCE groundwater contamination appeared to be limited to the area surrounding monitoring well OMS-28-5, which is located over 200 feet northwest of the fenced ALARNG property within a densely wooded area on MAA property, near its northern boundary with vacant property (**Figure 1-2**).

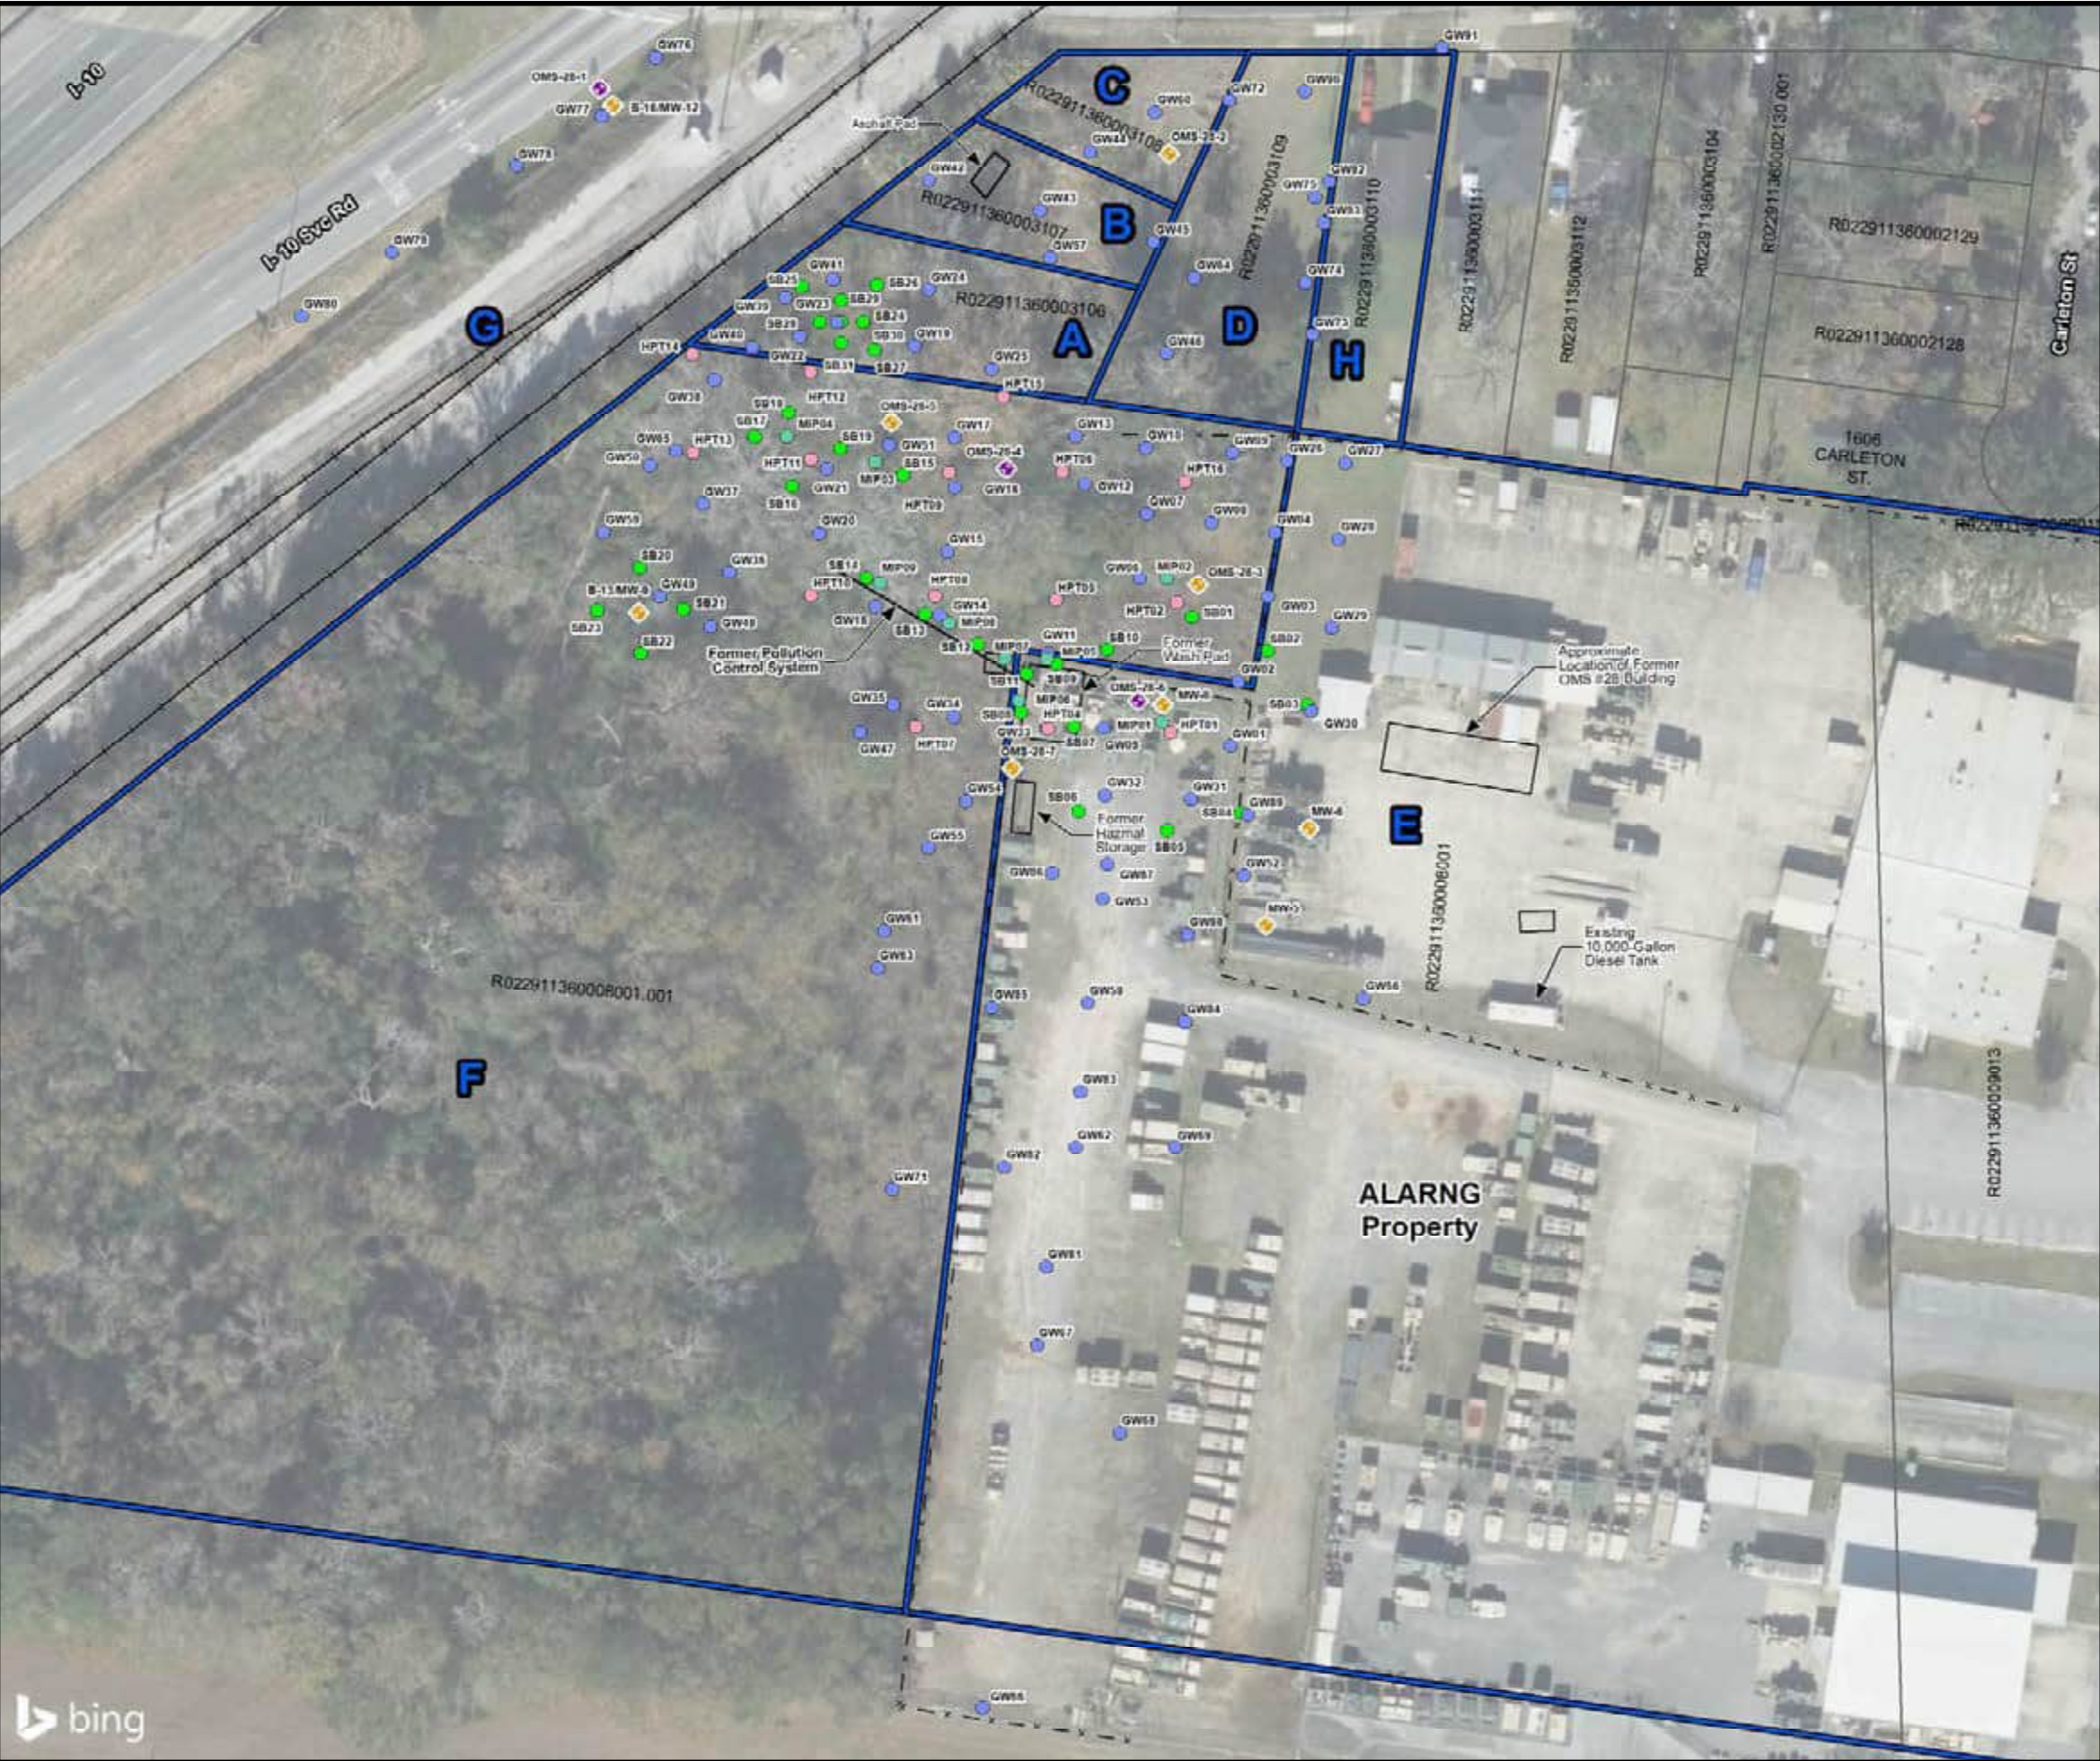
| PROJECT NO.<br>6066895 | DRAWN BY:<br>RJS | DATE:<br>10/12/2023 | Figure 1-3 |

The human health risk assessment (HHRA) conducted for the Risk Assessment Report, Revision 2 (AECOM, 2023) was conducted for the eight lettered parcels shown on **Figure 1-3** (Parcels A through H) in order to evaluate potential risk to human receptors at the site. For this assessment, risks and hazards were first determined and subsequently site-specific target levels (SSSLs) were developed for those receptors potentially exposed to site-related contaminants identified as chemicals of concern (COCs) in surface soil, subsurface soil, and groundwater at the eight separate parcels. Potential receptors and exposure pathways were evaluated based on current and future land-use scenarios. **Table 1-1** provides a summary of the SSSLs that were developed for the HHRA using the most recent USEPA RSL table (USEPA, 2022). A summary of the HHRA is provided below:

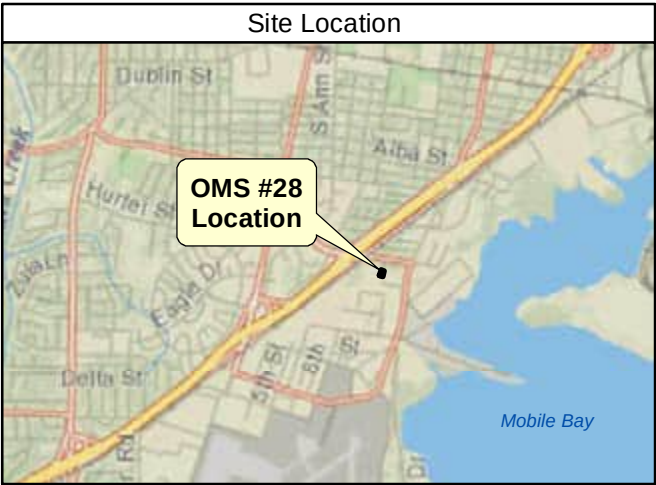
- Upper/Middle Surficial Monitoring Well Location
- Lower Surficial Monitoring Well Location
- Discrete Groundwater Sample Location
- HPT Location
- MIP Location
- Soil Boring Location
- Fenceline
- Railroad
- Parcel Boundary
- Parcel Designation (A - H)

An additional parcel, Parcel H (currently owned by Elnora Smith), is located immediately adjacent to and east of Parcel D. This parcel has a residential home located on it; however, SDGI activities were not conducted on Parcel H because access to this parcel was unable to be obtained. Groundwater grab samples collected along the property line between Parcel D and Parcel H, all had detections below the applicable MCLs. All eight parcels (A through H) in conjunction with associated SDGI sample locations are shown on **Figure 1-3**.

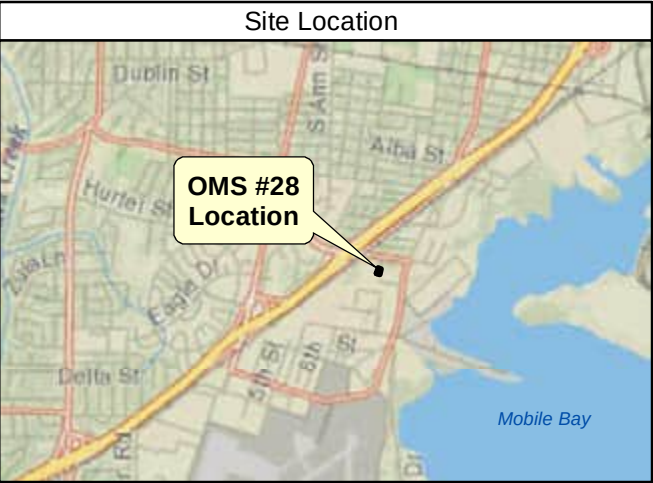
**Figure 1-13**

- Legend**
- Discrete Groundwater Sample Locations
  - Upper/Middle Surficial Monitoring Well Location
  - Lower Surficial Monitoring Well Location
  - Approximate extent of TCE Exceedance Above the MCL (5 µg/L)
  - Approximate extent of PCE Exceedance Above the MCL (5 µg/L)
  - Apparent Groundwater Flow Direction - May 2017
  - Fenceline
  - Railroad
  - Parcel Designation (A - H)
  - Parcel Boundary
  - Indicates TCE and/or PCE were detected above their respective MCL.

The areal extent of the Upper/Middle Surficial aquifer unit impacted by TCE above the MCL of 5 µg/L that emanates from the ALARNG property (Parcel E) is approximately 0.93 acres (**Figure 1-13**). Of the 0.93 acres of impacted groundwater, approximately 0.05 acres are located on Parcel D and 0.43 acres are located on heavily wooded Parcel F. The estimated areal extent of the isolated areas of the Lower Surficial aquifer unit impacted by TCE above 5 µg/L is 0.1 acres.

For the purposes of developing this alternative, the current areal extent of the TCE plume that is associated with historical ALARNG activities conducted on Parcel E is approximately 0.93 acres (**Figure 1-13**). Additional monitoring wells are needed to augment the existing site monitoring well network for the following reasons:

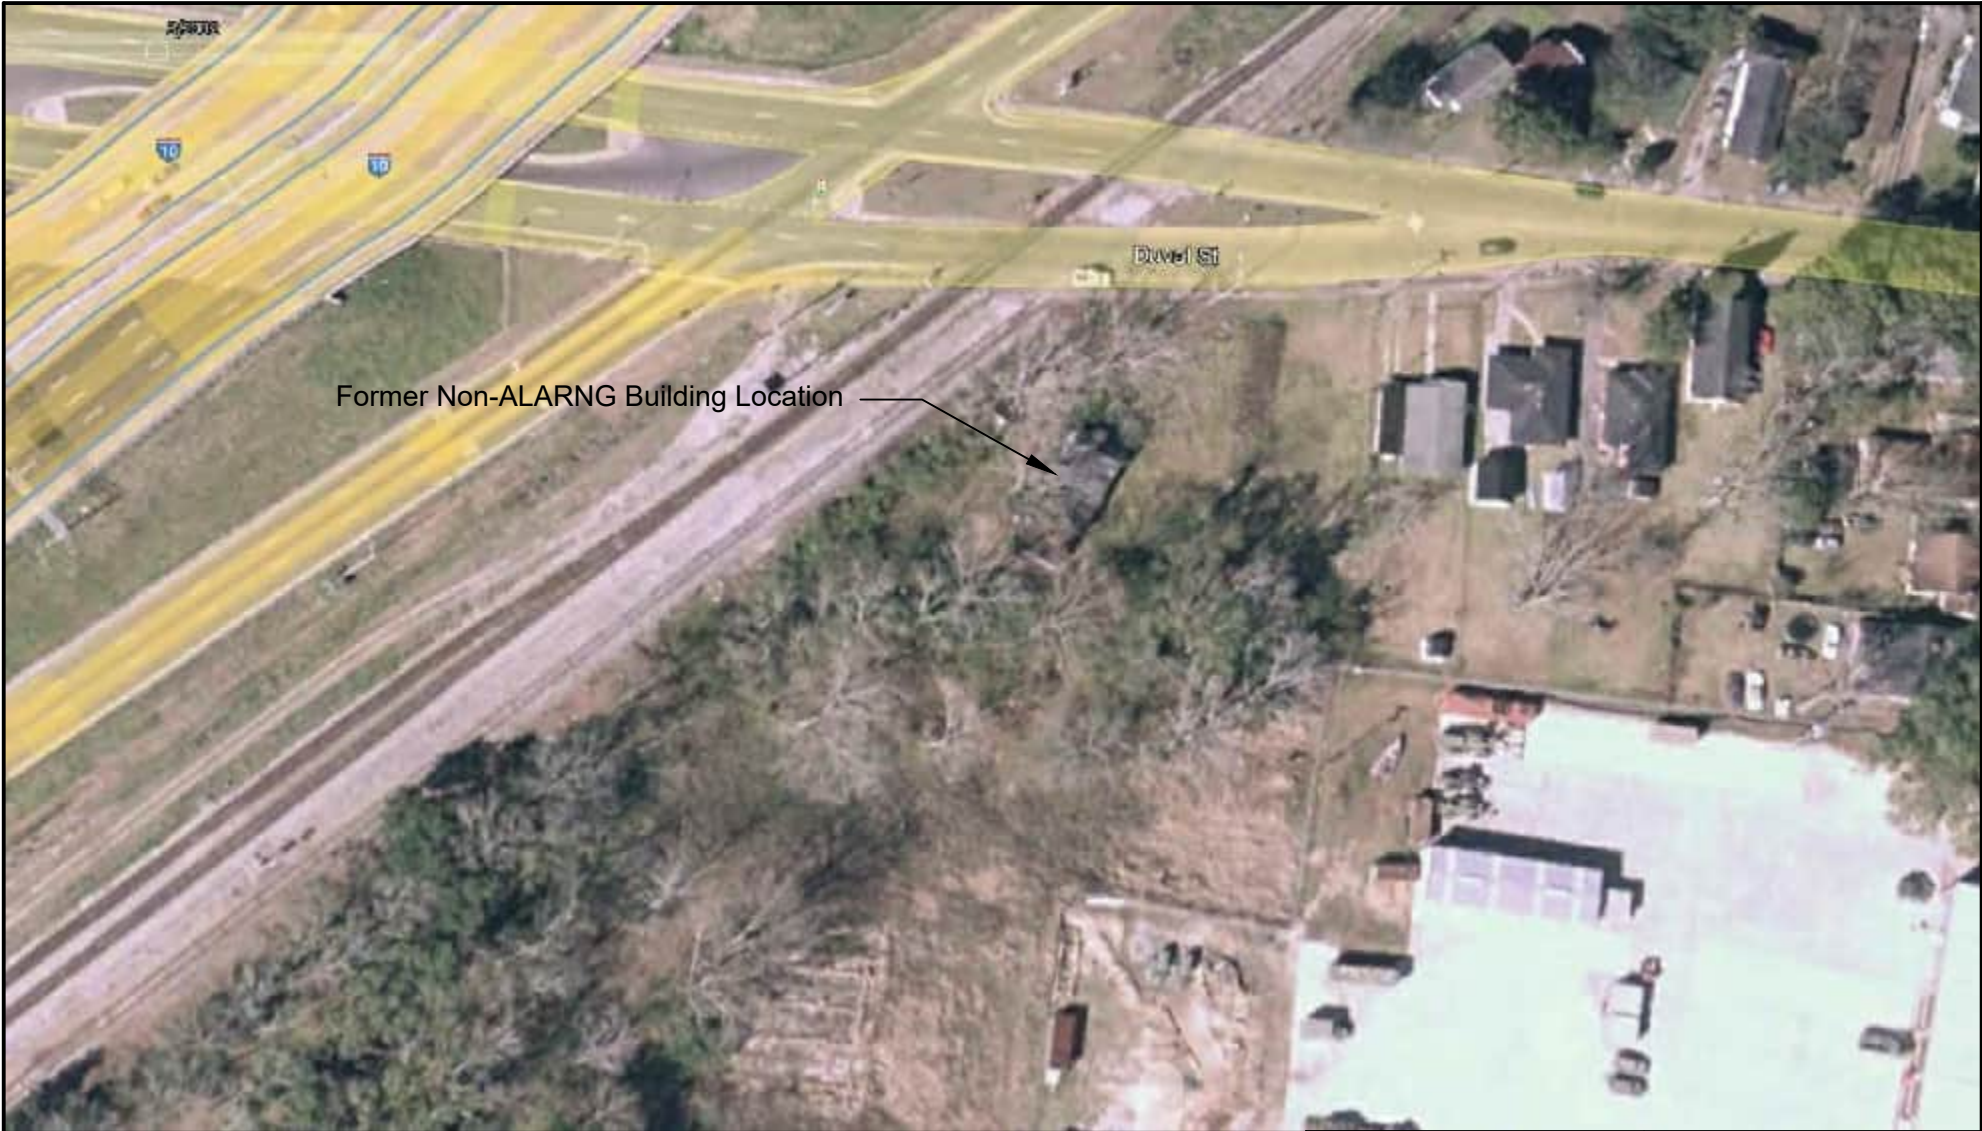
**Former Non-ALARNG Building on Parcels A and B  
(Google Earth Pro, 2002)**

Source:  
Google Earth Pro, 2002 Historical Aerial Photograph.

24.4 mg/kg at a depth of 1 foot above the water table (**Table C-3**). OMS-28-SB24 is located over 200 feet northwest of the fenced ALARNG property. A former non-ALARNG building was identified on Parcels A and B in a 2002 aerial photograph found on Google Earth Pro (**Attachment 2**).
